REPORT NO. UMTA-MA-06-0041-79-6

VIBRATION TESTS ON TRANSIT BUSES

MARCH 1979

FINAL REPORT

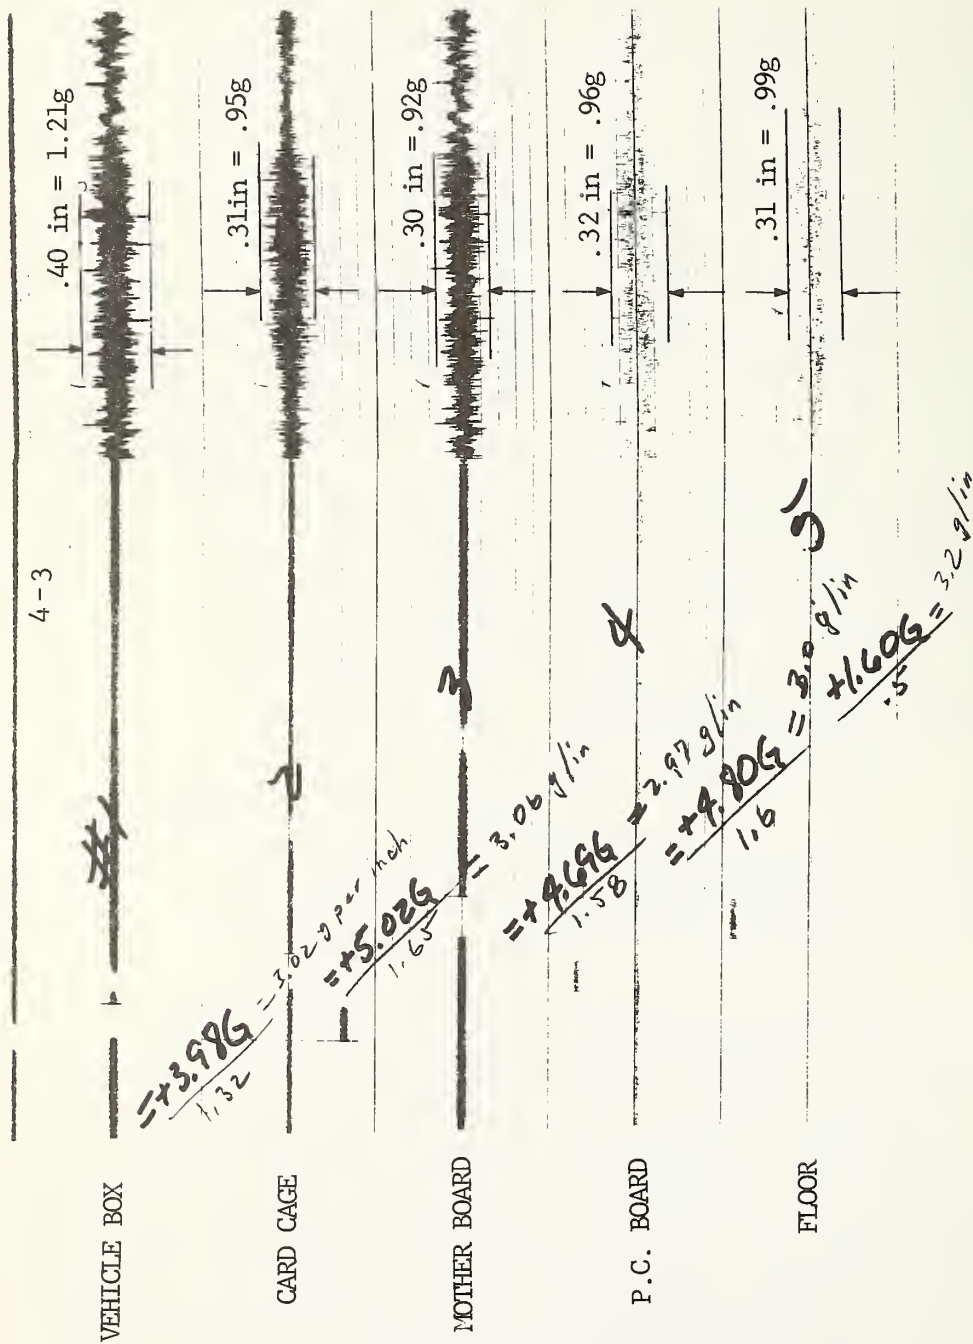
FIGURE 2-4. AMPLITUDE DETERMINATION (FROM TEST NO. 17 - FLXIBLE BUS)

The maximum amplitude associated with each accelerometer for each significant test condition encountered in each test run was tabulated. This was felt to be a conservative application of the

Examples of amplitude determination and frequency counting are given in Figures 2-4 and 2-5, respectively.

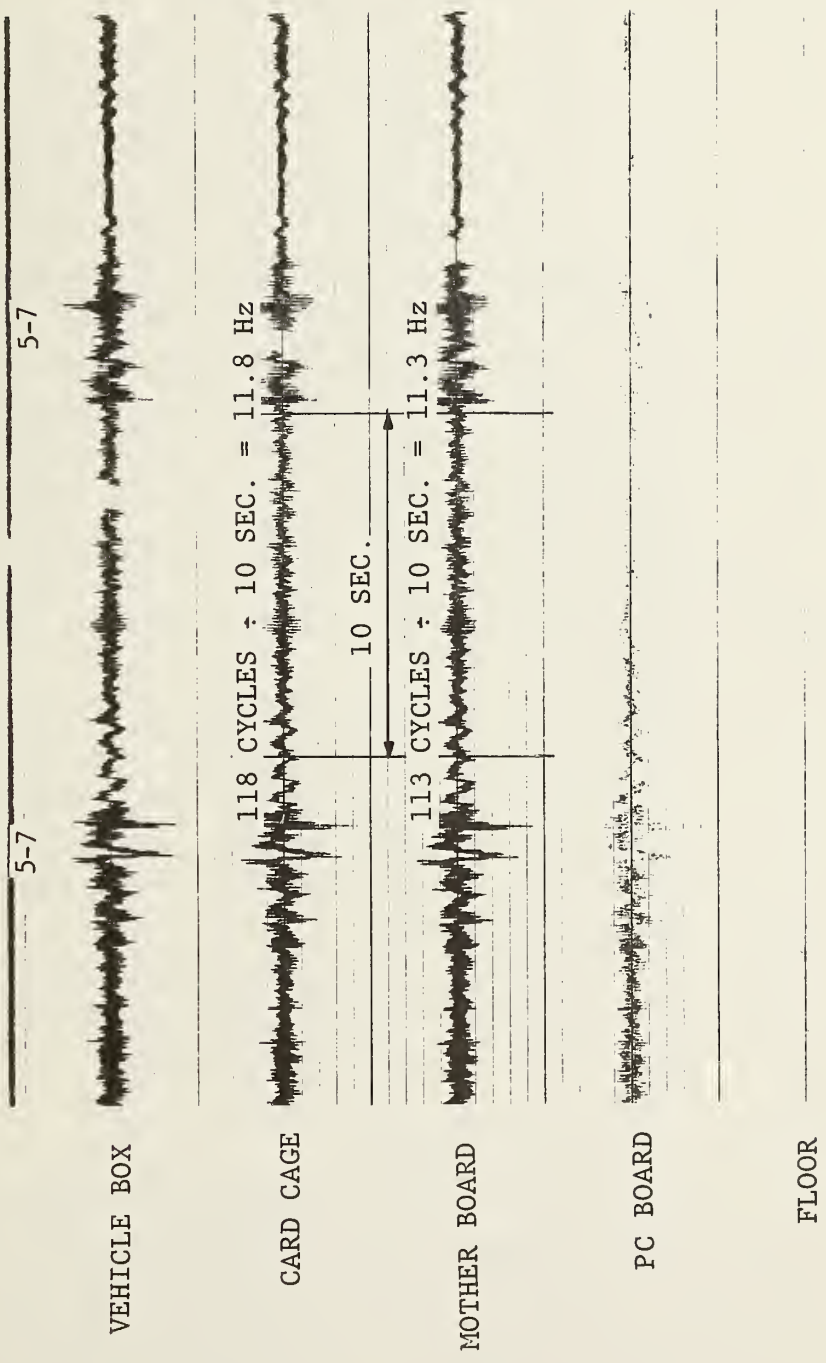
FIGURE 2-5. FREQUENCY COUNTING (FROM TEST NO. 18 - FLXIBLE BUS)

In addition to the amplitude-versus-test condition data, some vibration frequency counting was accomplished. Timing marks on the paper records correspond to one-second intervals of elapsed time. When the paper speed was sufficiently fast to separate the vibration traces into individual peaks, the number of peaks in an interval divided by the elapsed time of the interval gives the frequency of the vibration signal. The accuracy of this procedure is somewhat controlled by the clearness of the vibration signal, which is really a composite of all the frequencies present in the

vibration (within the frequency range of the recorder) superimposed on each other. However, the vibrating structure usually has distinct resonances which dominate the signal.

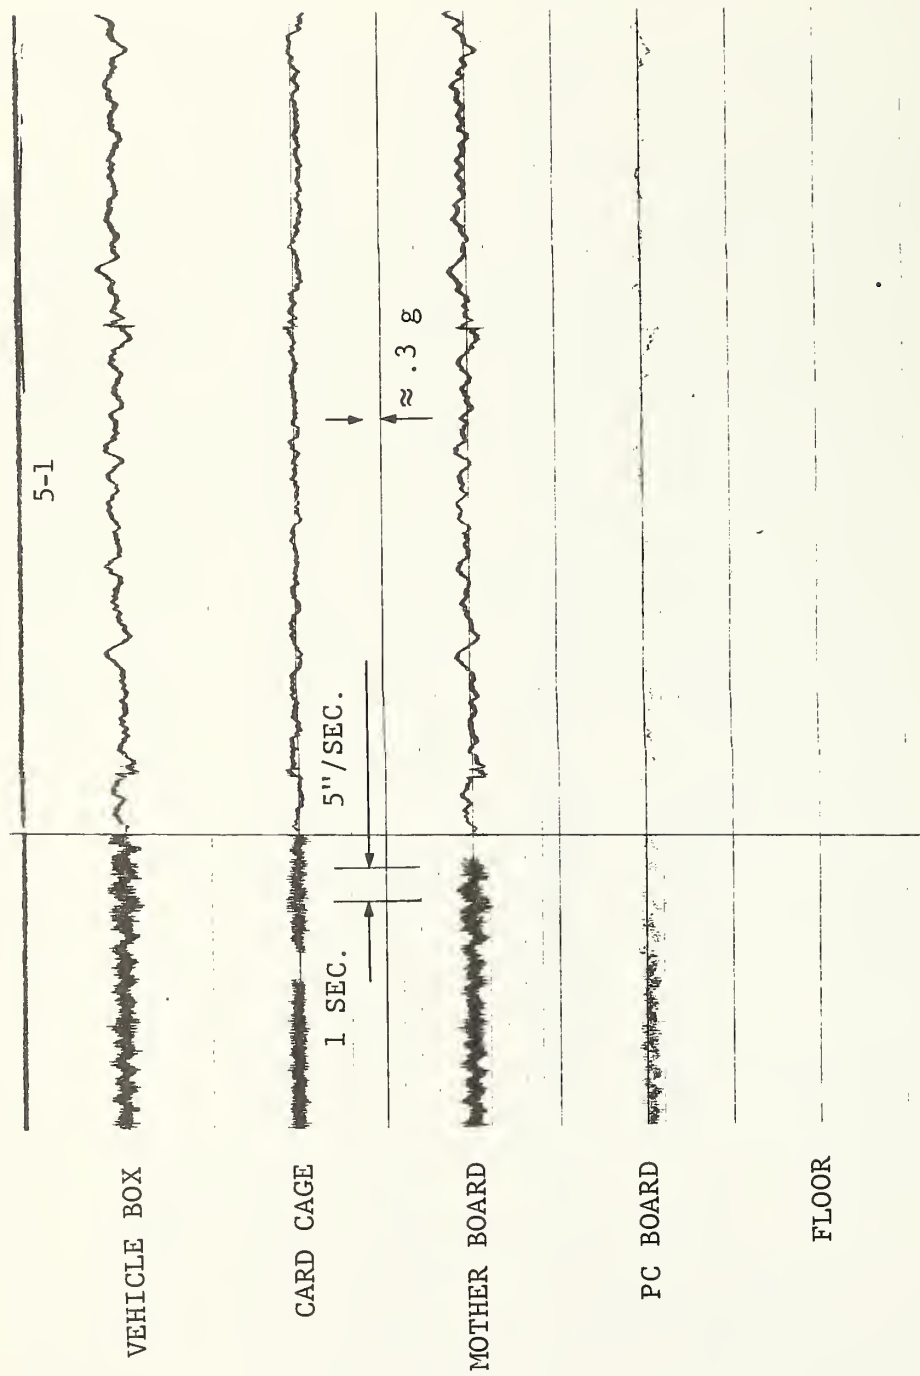
FIGURE 3-2. VIBRATION TIME HISTORY, 25-35 MPH - SMOOTH STREET
(FROM TEST NO. 18 - FLXIBLE BUS)

Short segments of the vibration time history records are presented in Figures 3-1 through 3-12 to illustrate the variation of the vibration characteristics with test conditions.

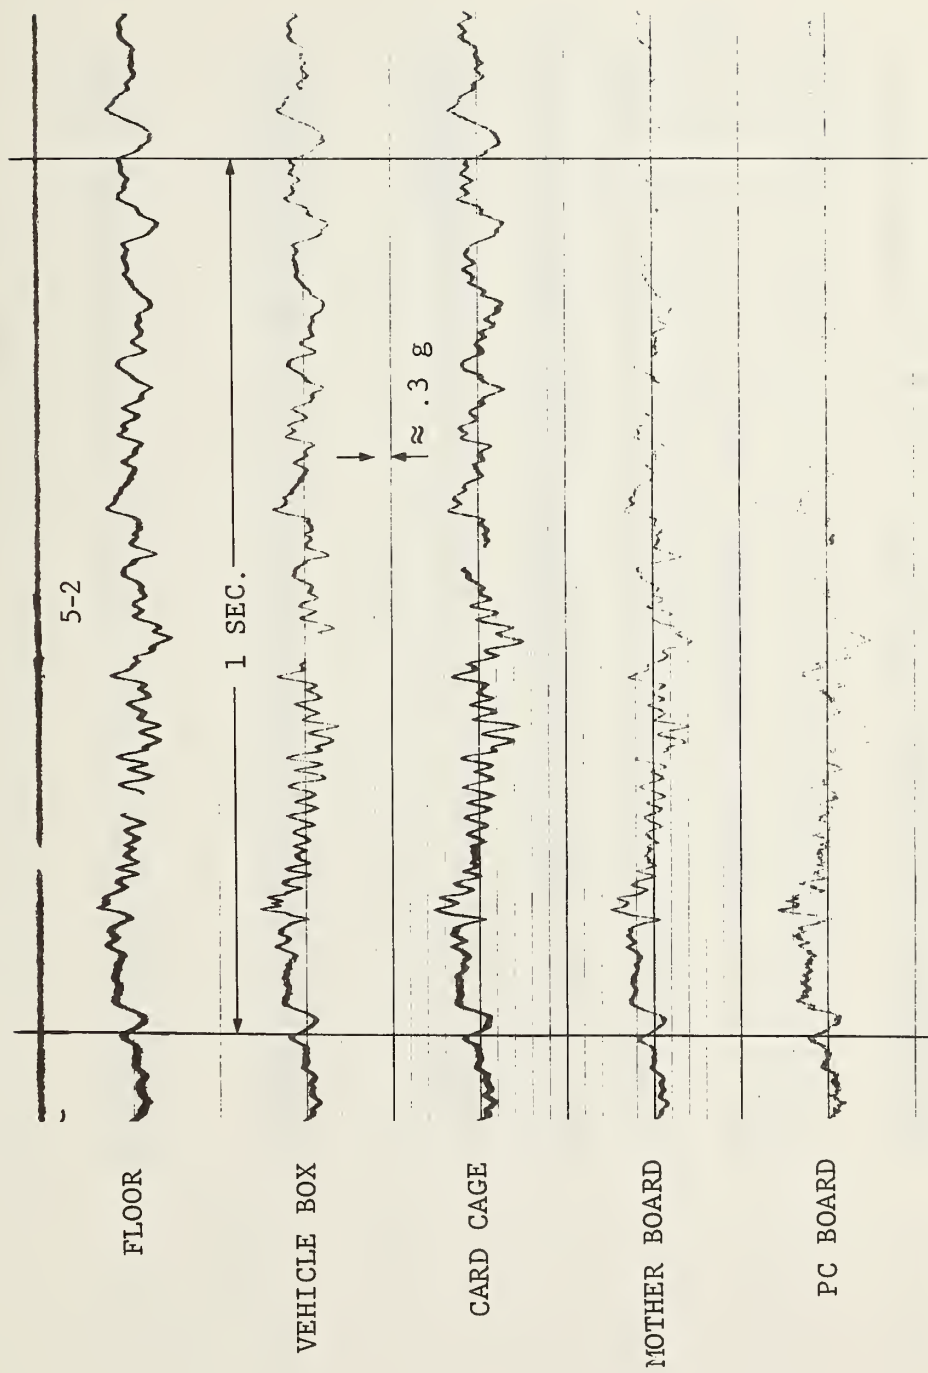
FIGURE 3-3. VIBRATION TIME HISTORY, 25-35 MPH - BUMPY STREET
(FROM TEST NO. 13 - GMC BUS)

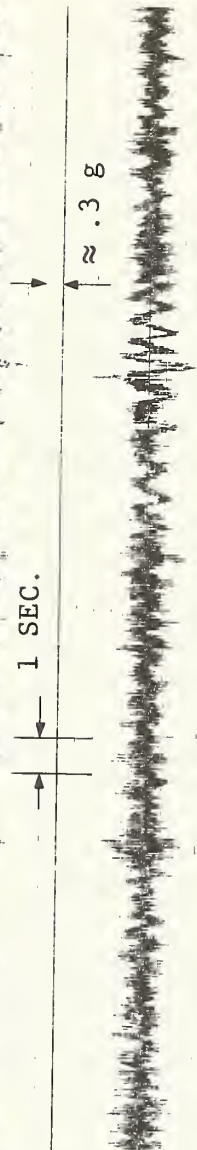
FIGURE 3-4. VIBRATION TIME HISTORY, 25-35 MPH - BUMPY STREET
(FROM TEST NO. 19 - FLXIBLE BUS)

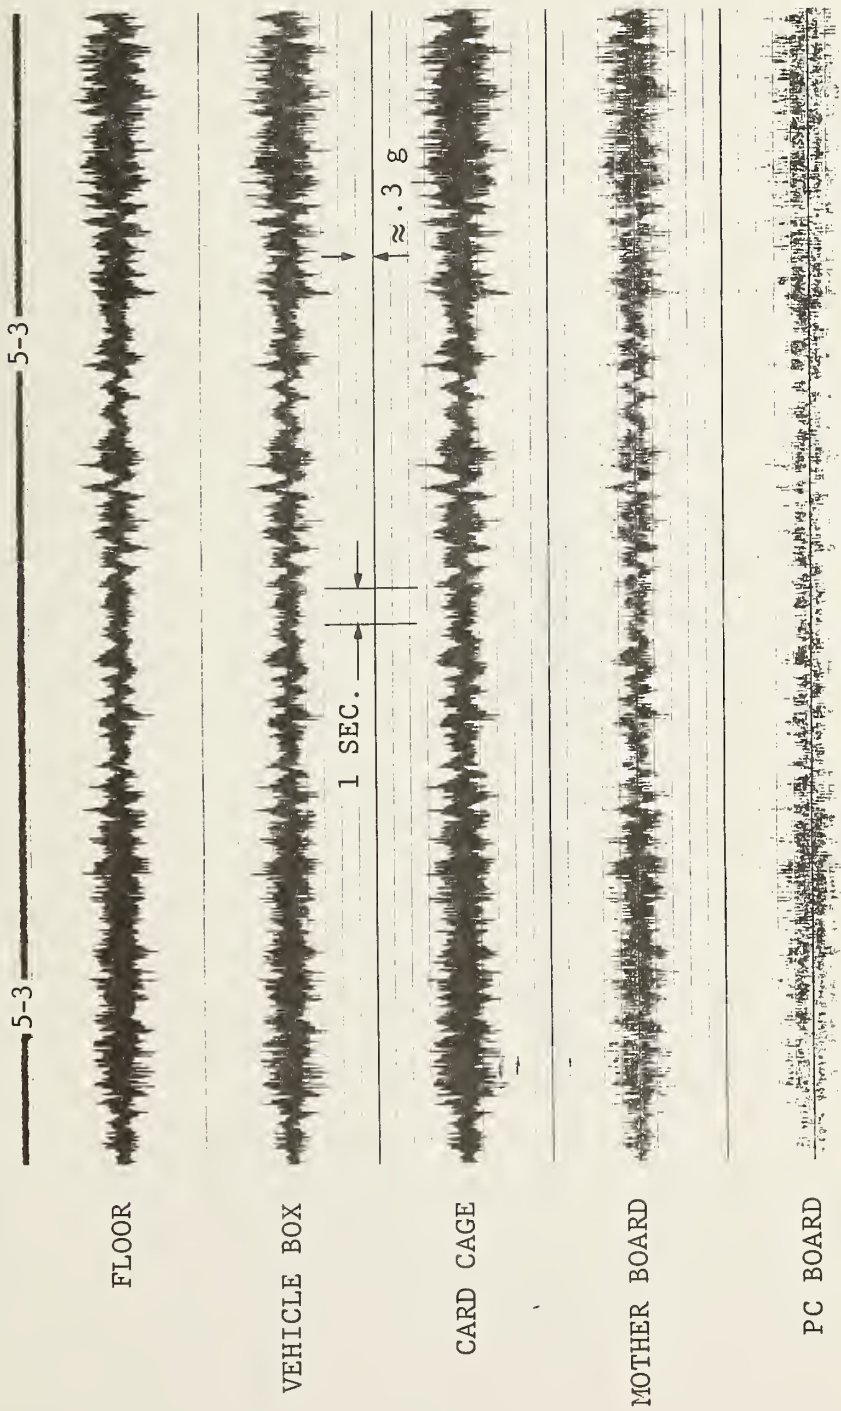
FIGURE 3-5. VIBRATION TIME HISTORY, 25-35 MPH - RR TRACKS IN STREET
(FROM TEST NO. 13 - GMC BUS)

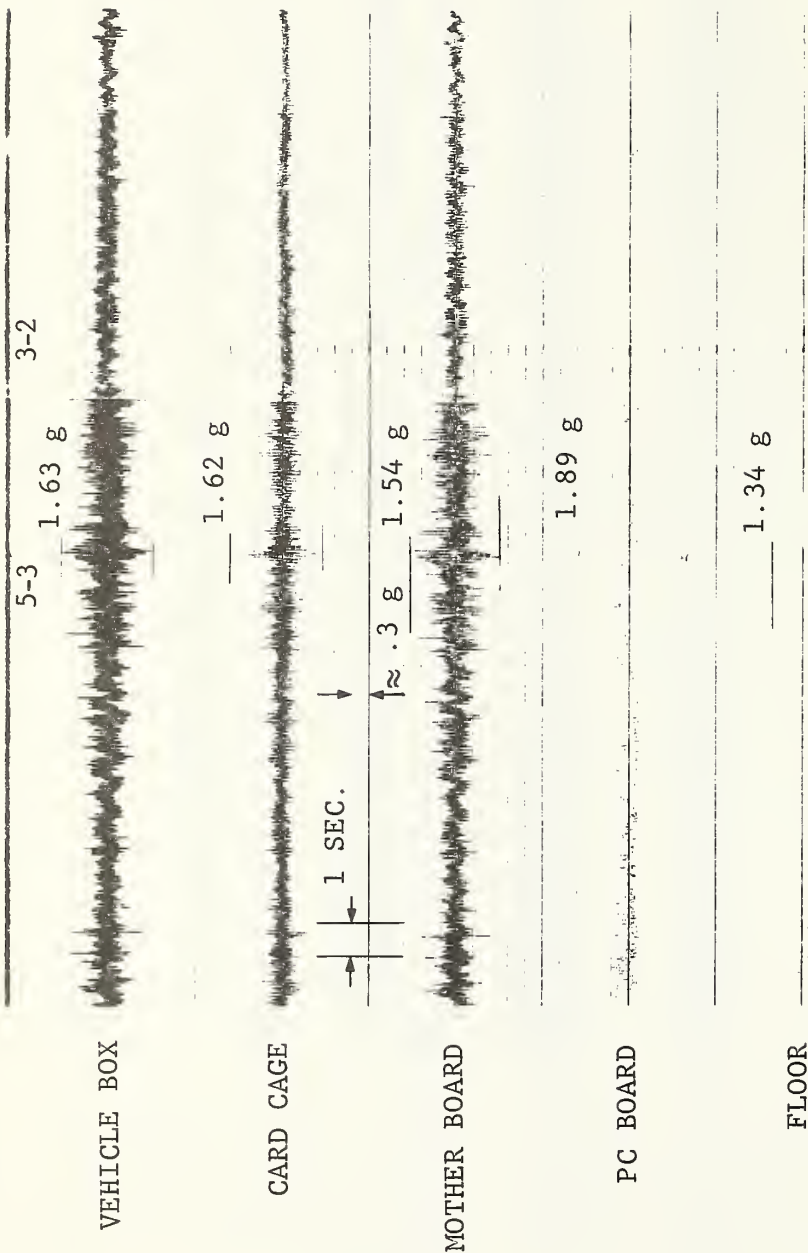
FIGURE 3-6. VIBRATION TIME HISTORY, 25-35 MPH - RR TRACKS IN STREET
(FROM TEST NO. 17 - FLXIBLE BUS)

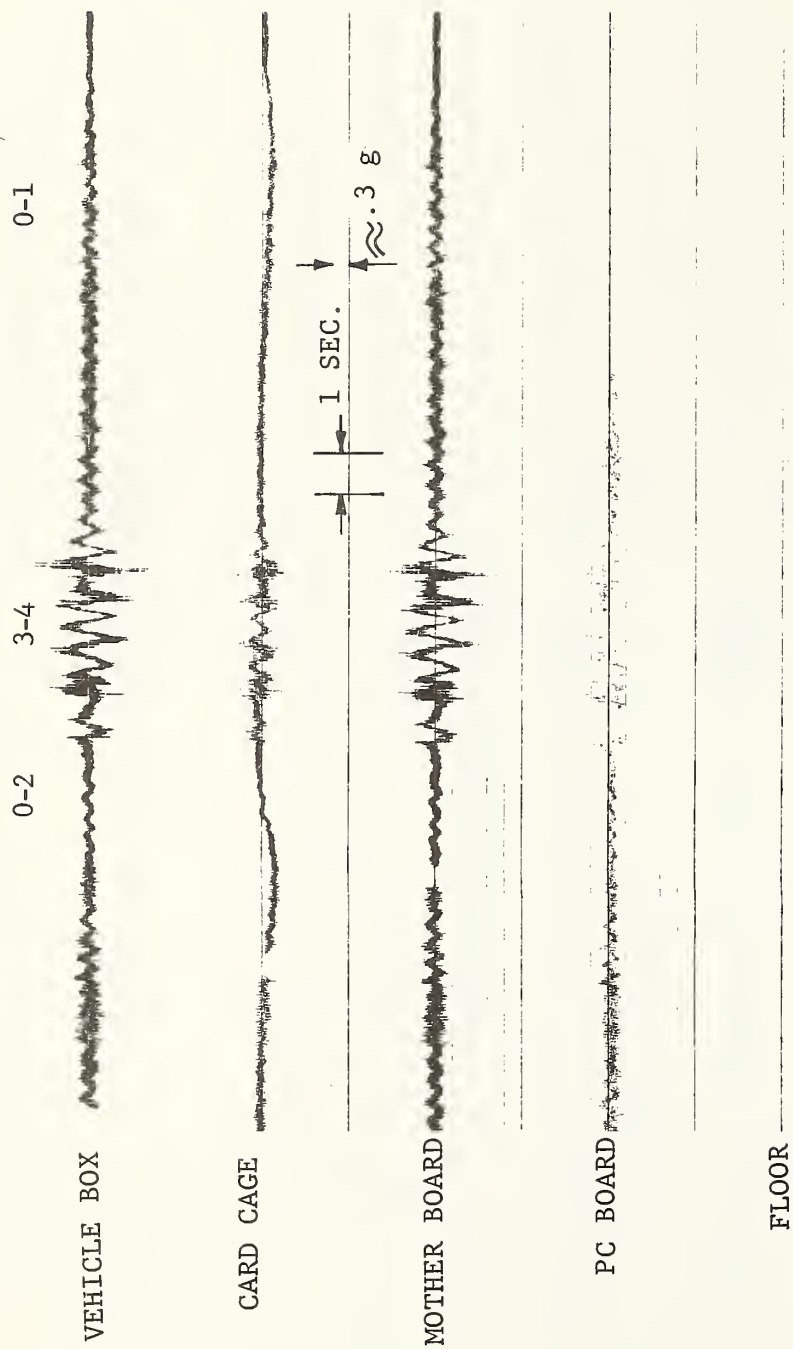
FIGURE 3-8. VIBRATION TIME HISTORY, 15-20 MPH - MULTIPLE RR CROSSING
(FROM TEST NO. 18 - FLXIBLE BUS)

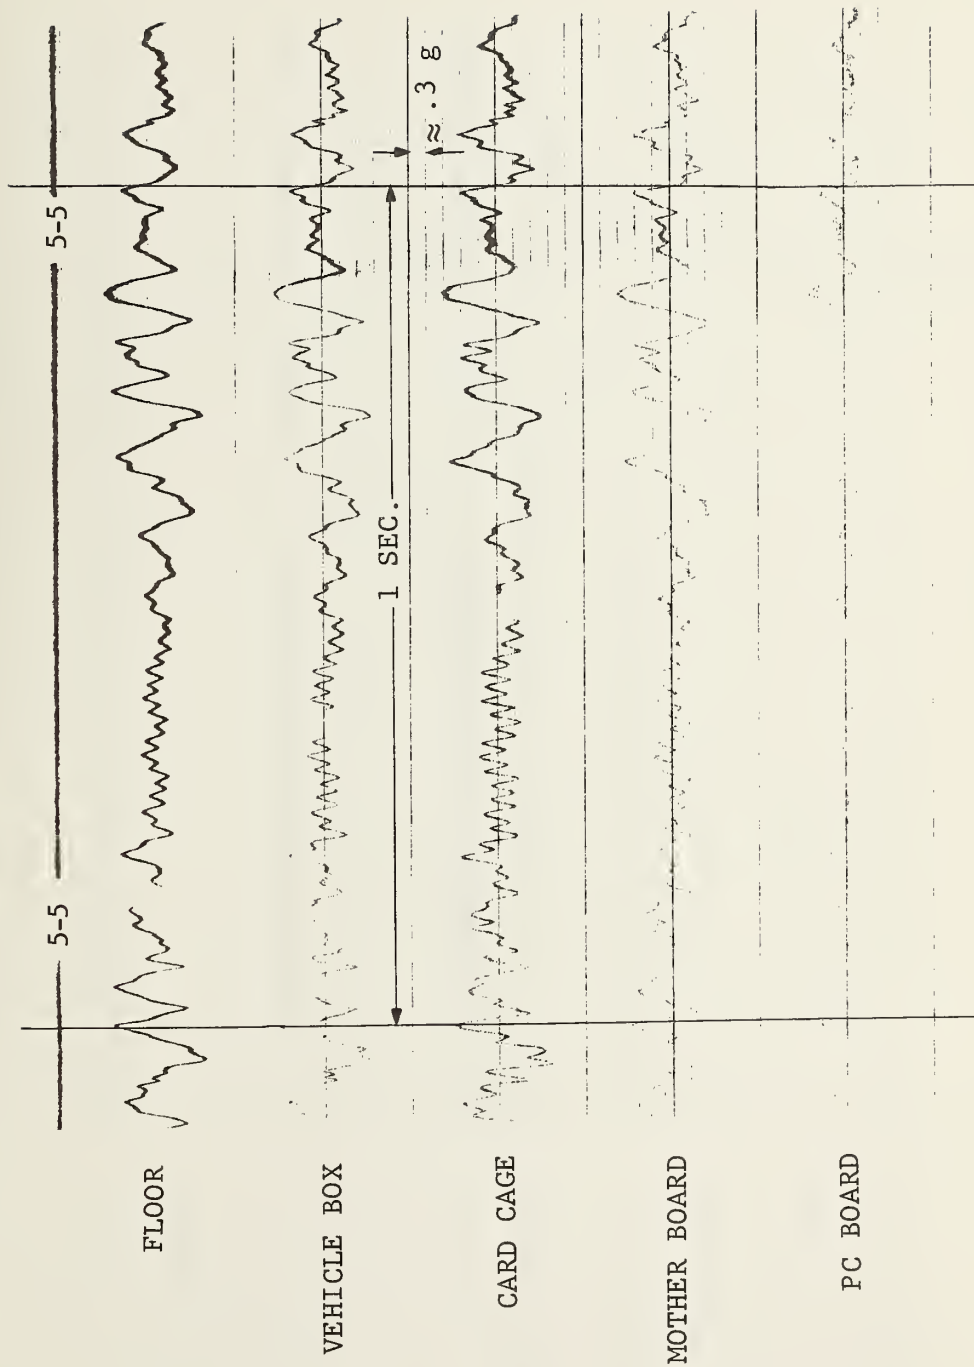
FIGURE 3-9. VIBRATION TIME HISTORY, 25-35 MPH - SPEED BUMPS
(FROM TEST NO. 12 - GMC BUS)

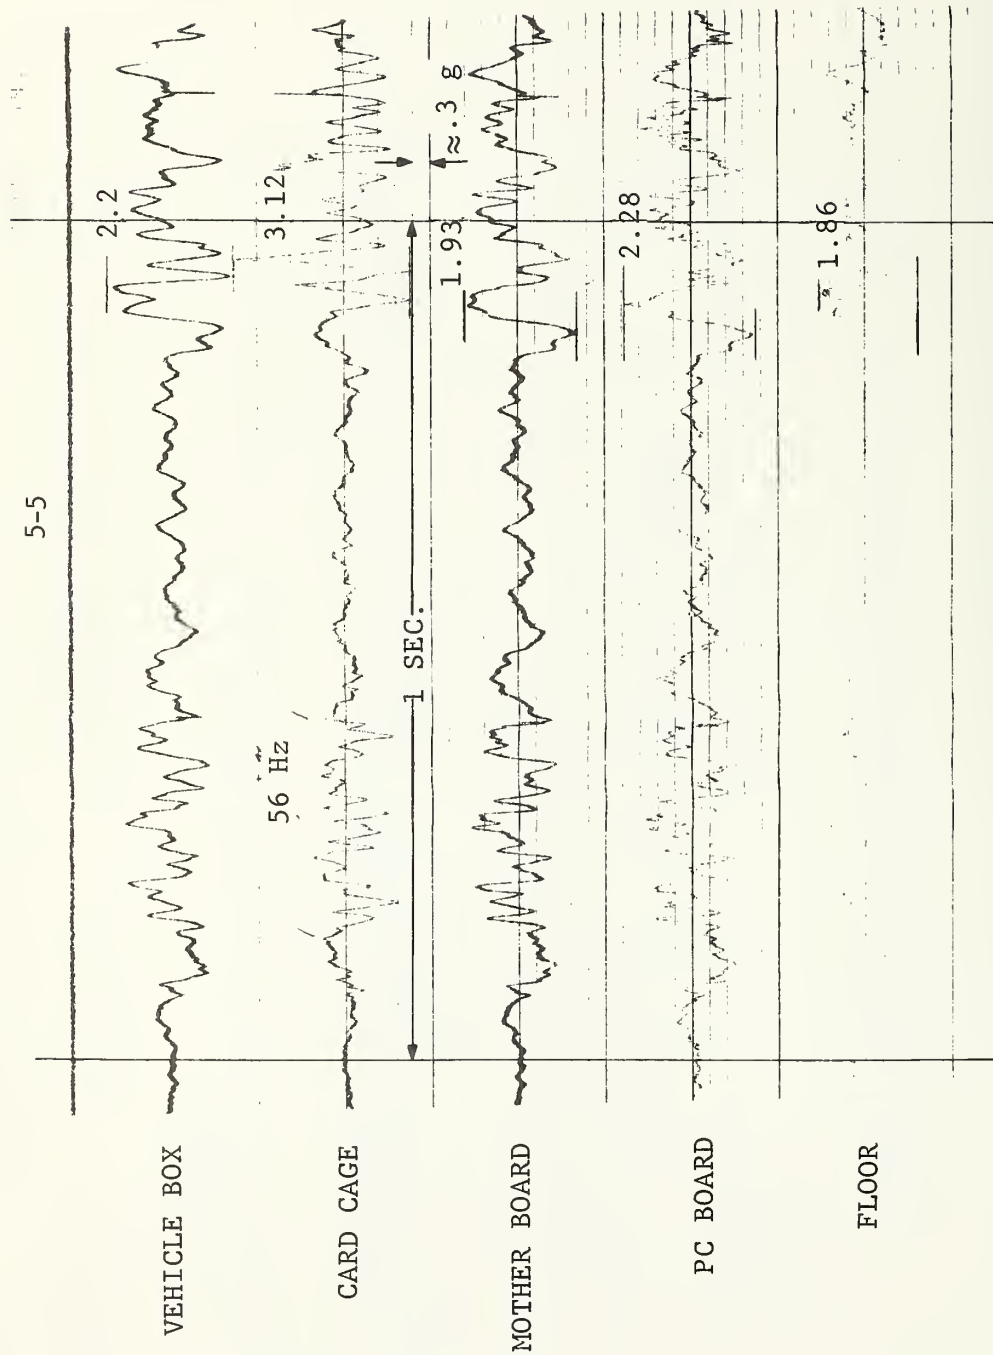
FIGURE 3-10. VIBRATION TIME HISTORY, 25-35 MPH - SPEED BUMPS
(FROM TEST NO. 17 - FLXIBLE BUS)

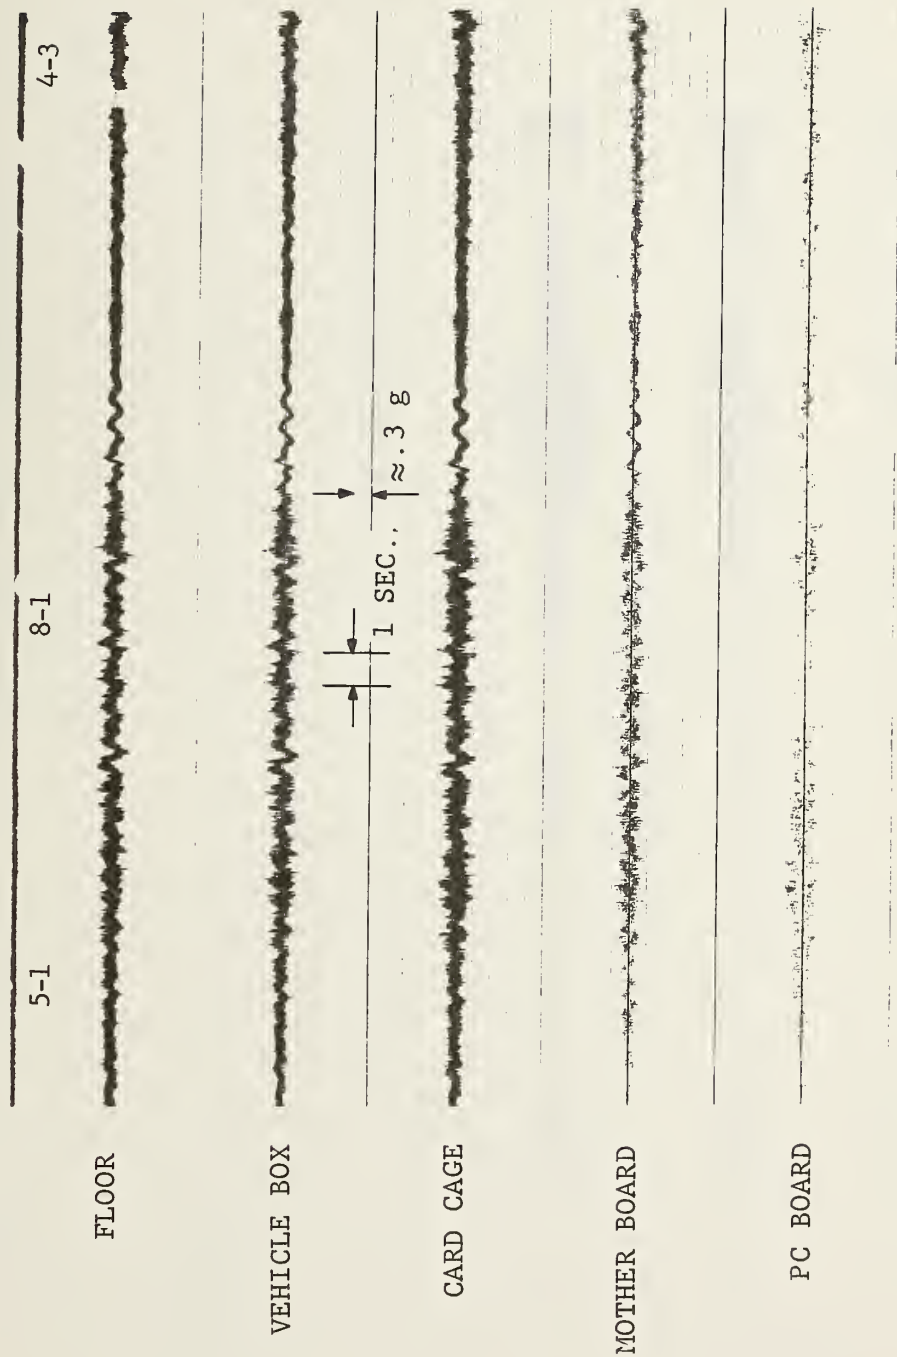
FIGURE 3-11. VIBRATION TIME HISTORY, PANIC STOP - SMOOTH STREET
(FROM TEST NO. 13 - GMC BUS)

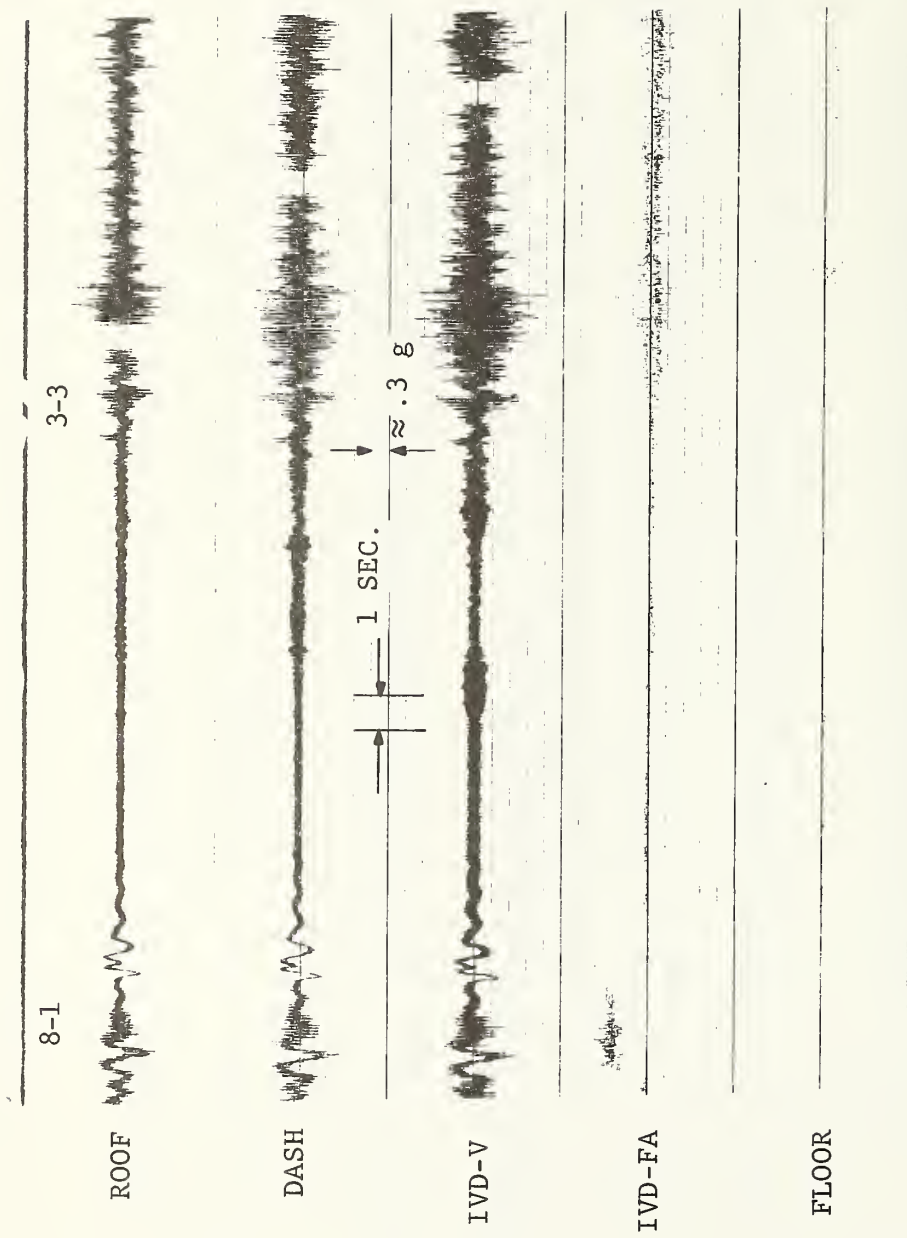
FIGURE 3-12. VIBRATION TIME HISTORY, PANIC STOP - SMOOTH STREET
(FROM TEST NO. 20 - FLXIBLE BUS)

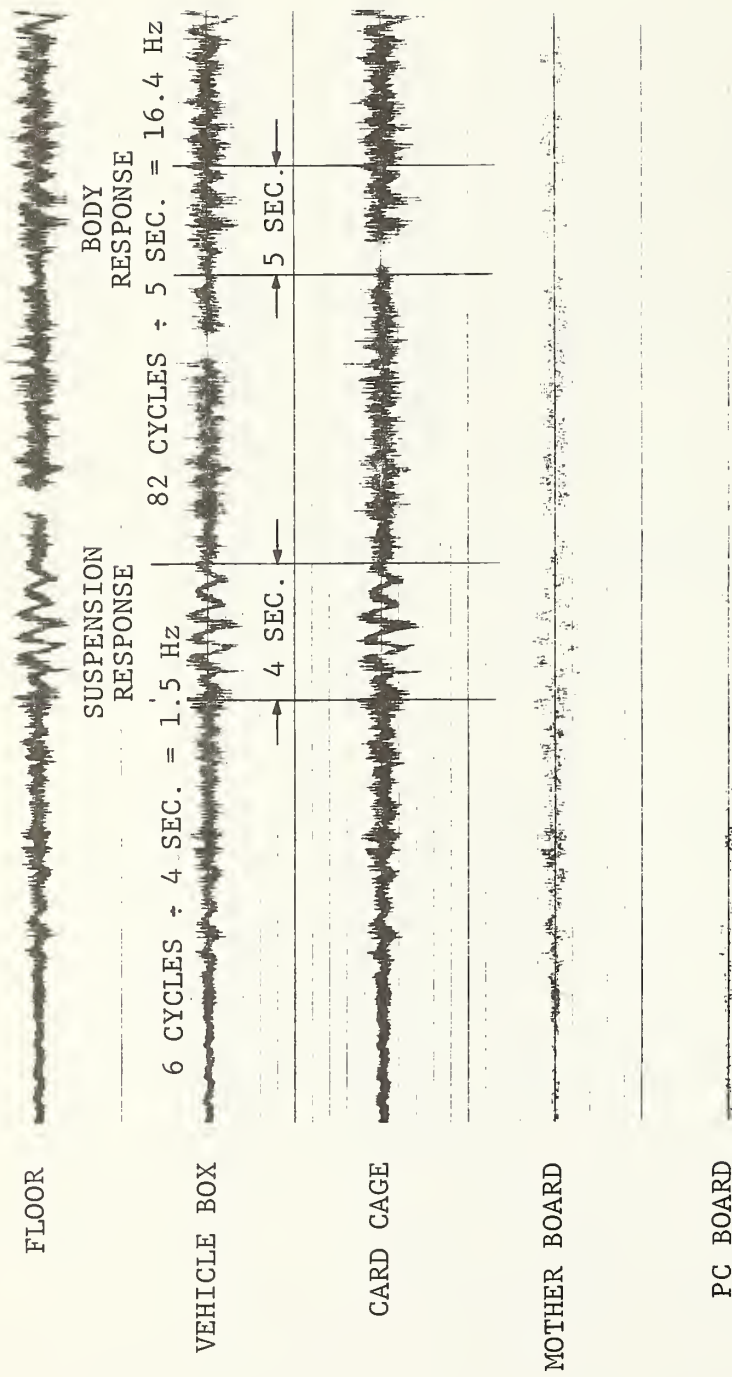
FIGURE 3-13. SUSPENSION AND BODY FREQUENCIES (FROM TEST NO. 12 - GMC BUS)

Basically, three response frequency ranges are observable in the data from both buses, though some differences exist between the two. The lowest frequency is noticed when the bus rolls over a series of closely spaced bumps and is believed to be the natural frequency of the suspension system. The second and third frequencies are observed generally throughout the data rising and falling

in amplitude in proportion to the bus speed or the roughness of the road or both. These frequencies are believed to be the predominant natural frequency of the bus body and the response frequency of the local component to which the accelerometer is attached. This latter frequency can only be detected in the records produced when the paper travels at a speed of 5 inches per second, although it is present during all operations. It is also not nearly as constant as the lower frequencies. Figures 3-13 and 3-14 are examples of data records which illustrate some of the identifiable frequencies. Table 3-1 lists the frequency ranges observed on the two buses.

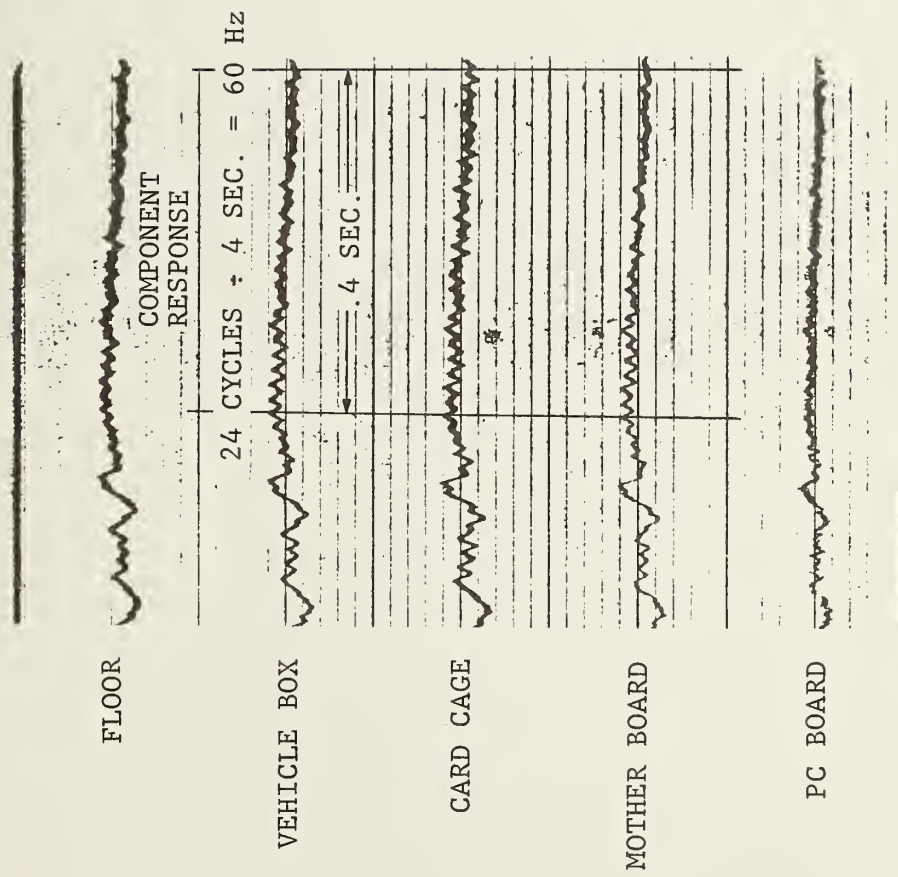
FIGURE 3-14. COMPONENT FREQUENCY (FROM TEST NO. 12 - GMC BUS)

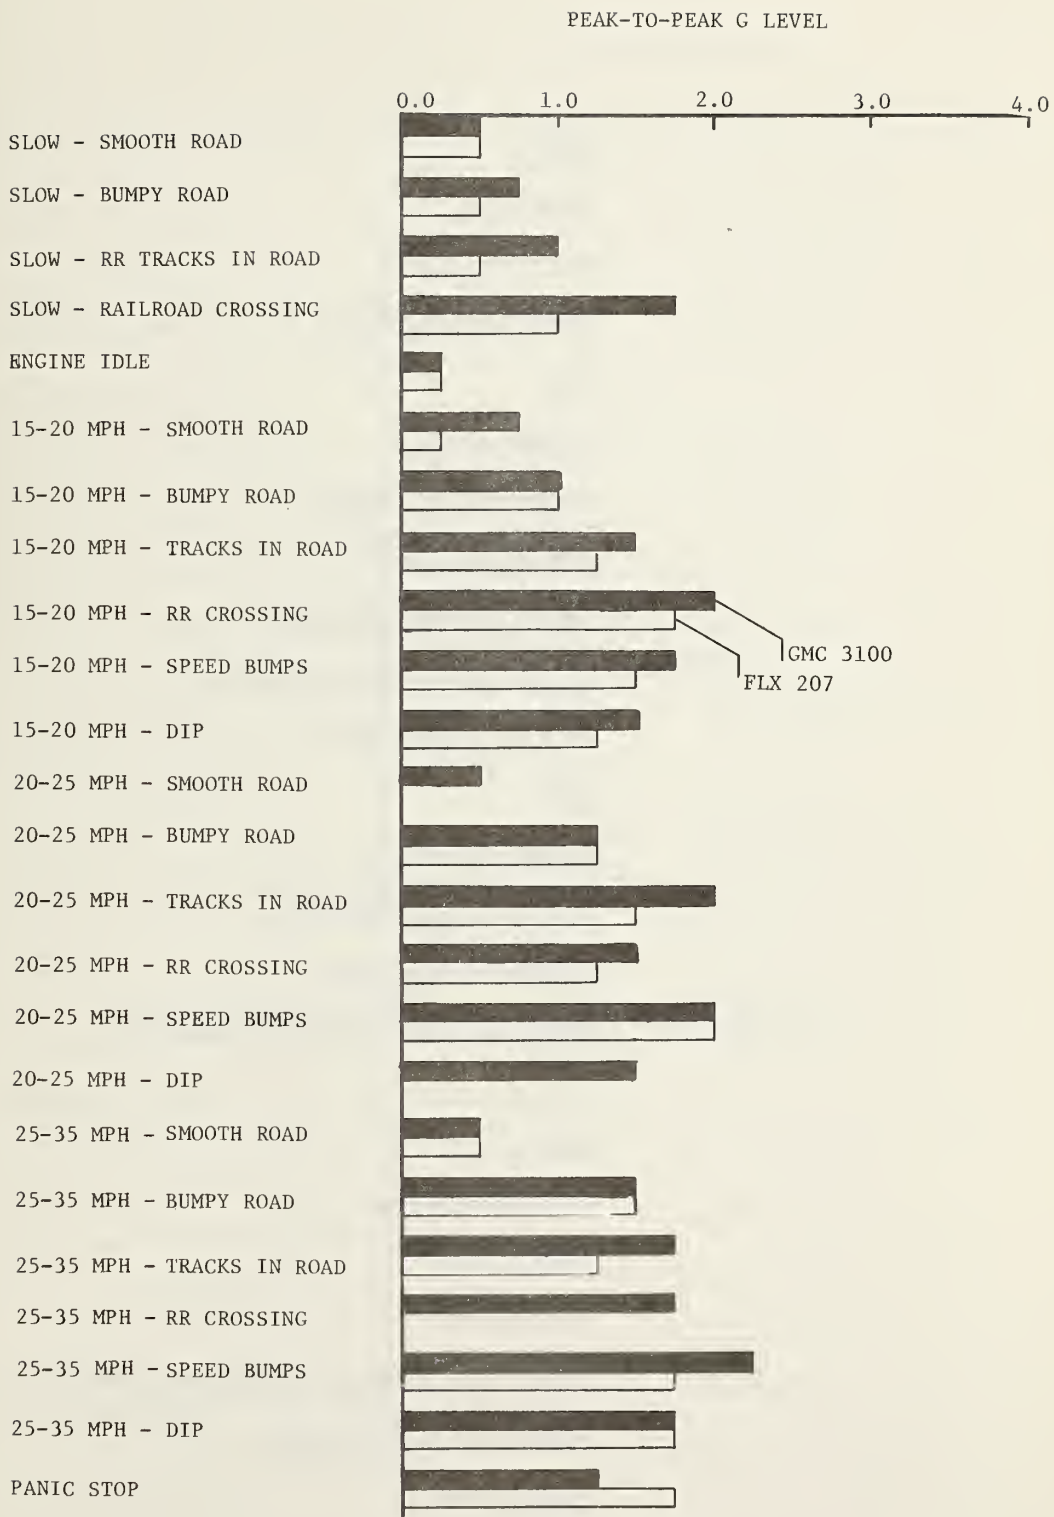
FIGURE 3-15. MAXIMUM VIBRATION LEVELS - FLOOR VERTICAL ACCELEROMETER

These data are plotted in bar graph form in Figures 3-15, 3-16, and 3-17 for the floor, dashboard, and roof accelerometers. The establishment of maximum vibration amplitudes observed in the data for various accelerometer positions during any of the test runs is believed to describe an upper bound for vibration levels which can be expected of AVM system component locations on buses in normal city route service.

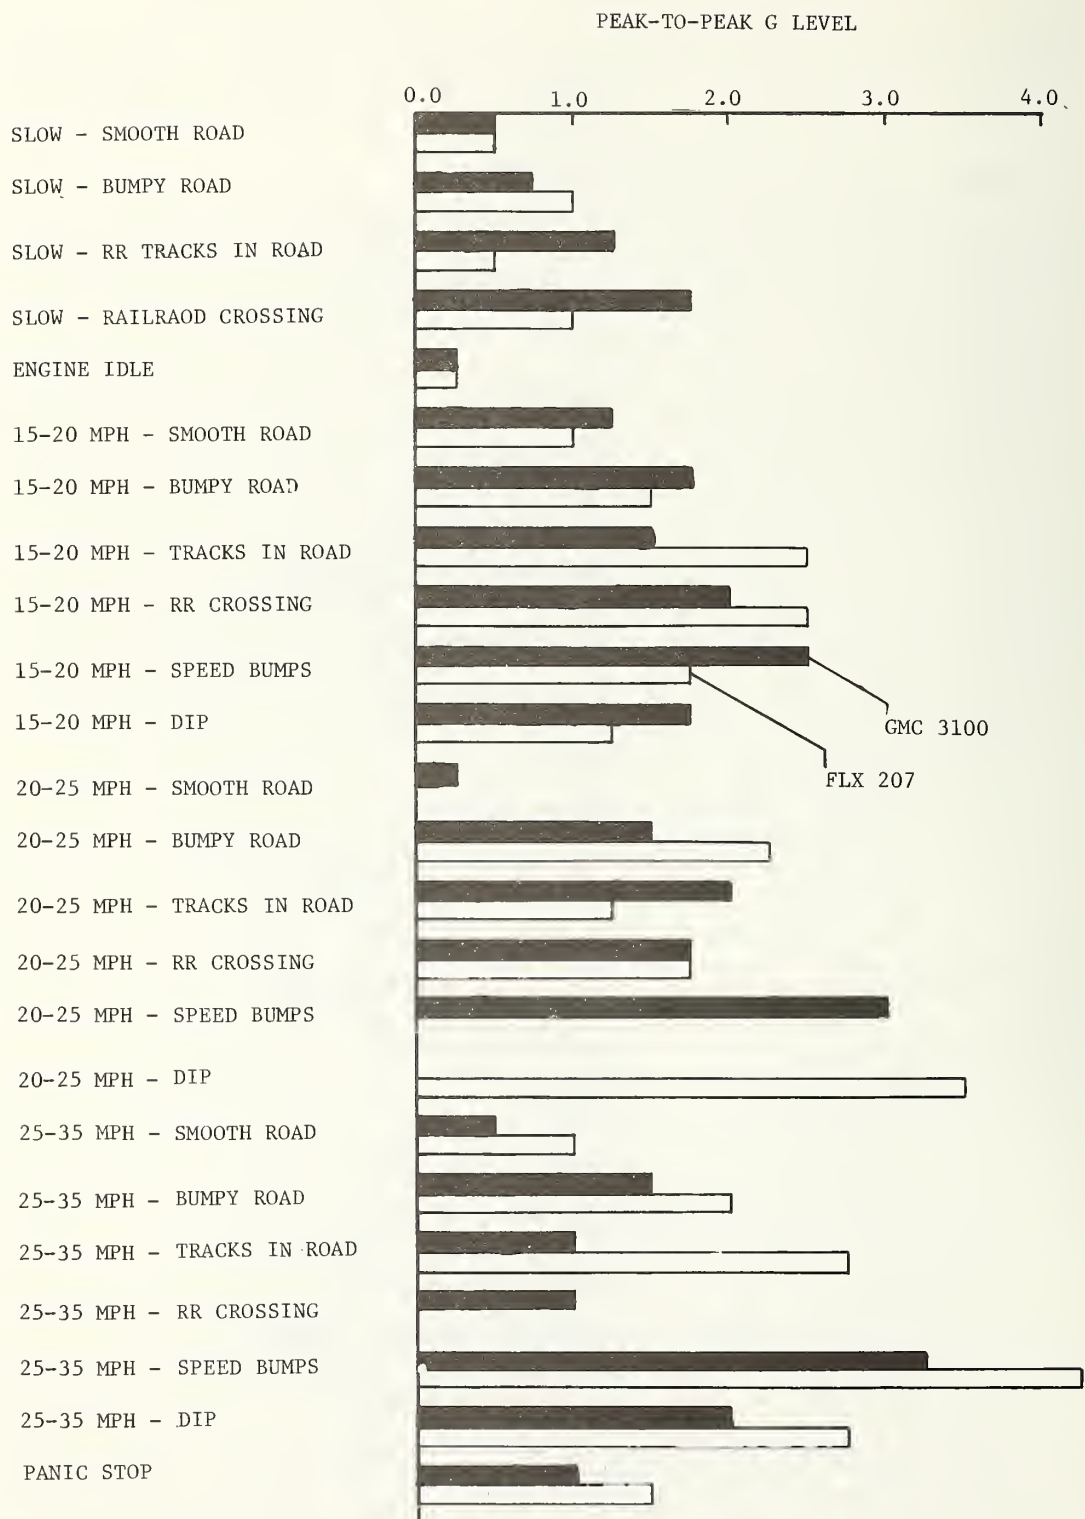
FIGURE 3-16. MAXIMUM VIBRATION LEVELS - DASHBOARD VERTICAL ACCELEROMETER

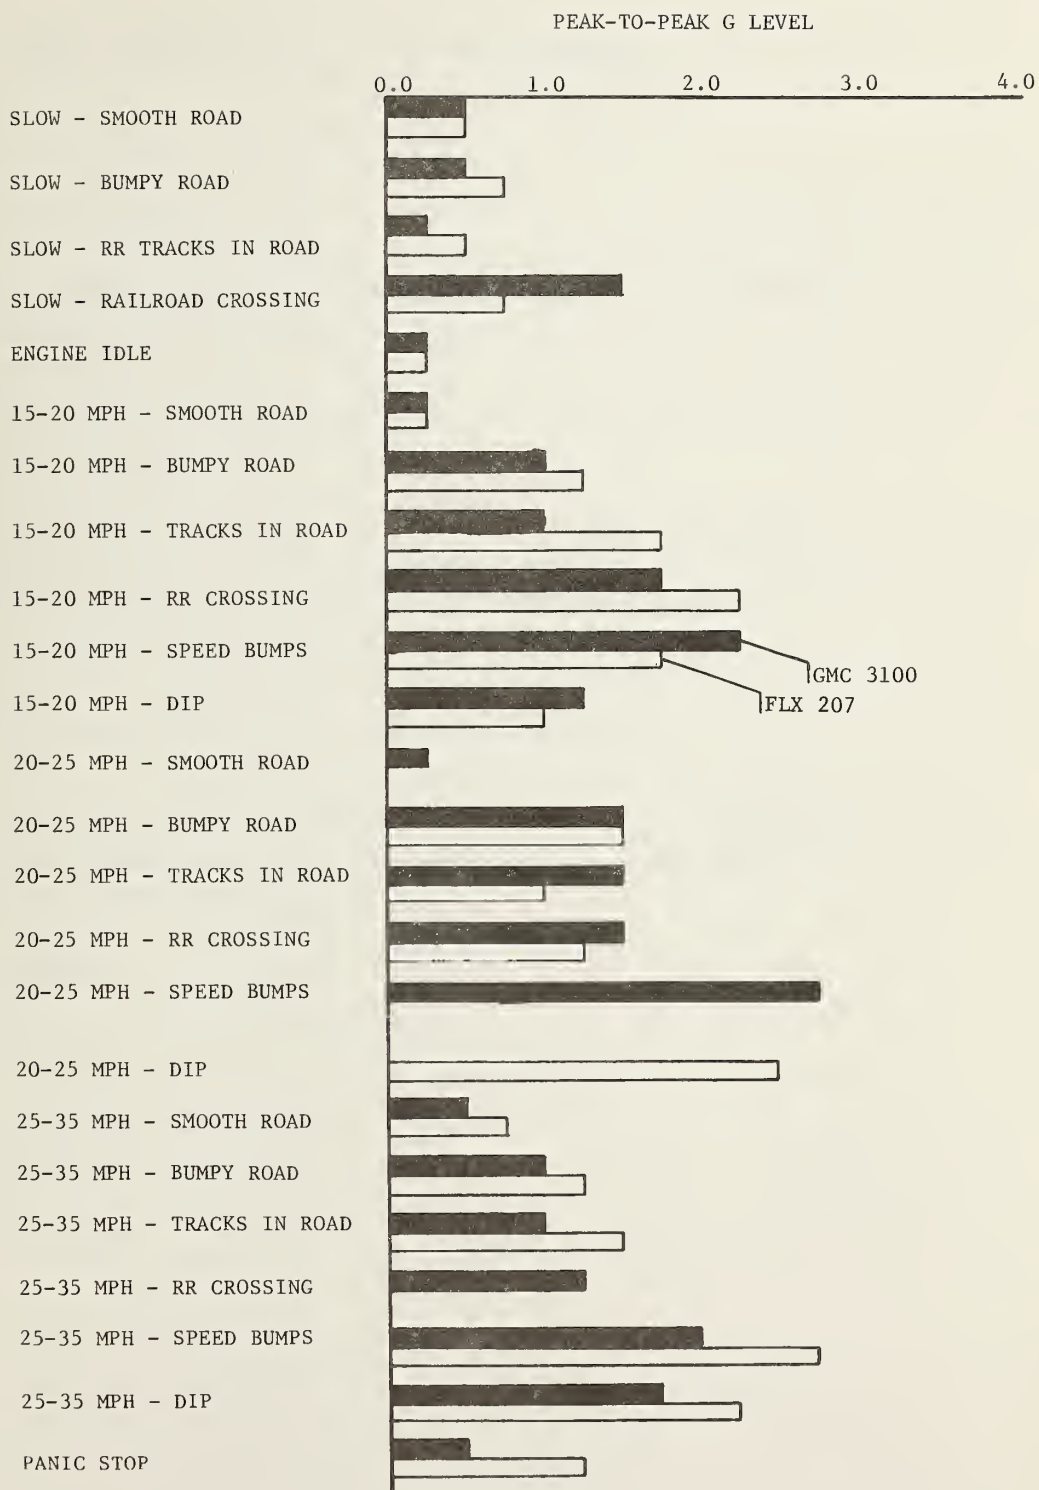
FIGURE 3-17. MAXIMUM VIBRATION LEVELS - ROOF VERTICAL ACCELEROMETER
